**MARYLAND HISTORICAL TRUST
NR-ELIGIBILITY REVIEW FORM**

Property Name: Oxford Farm Inventory Number: T-1141

Maryland Inventory of Historic Properties Form

Inventory No. T-1141

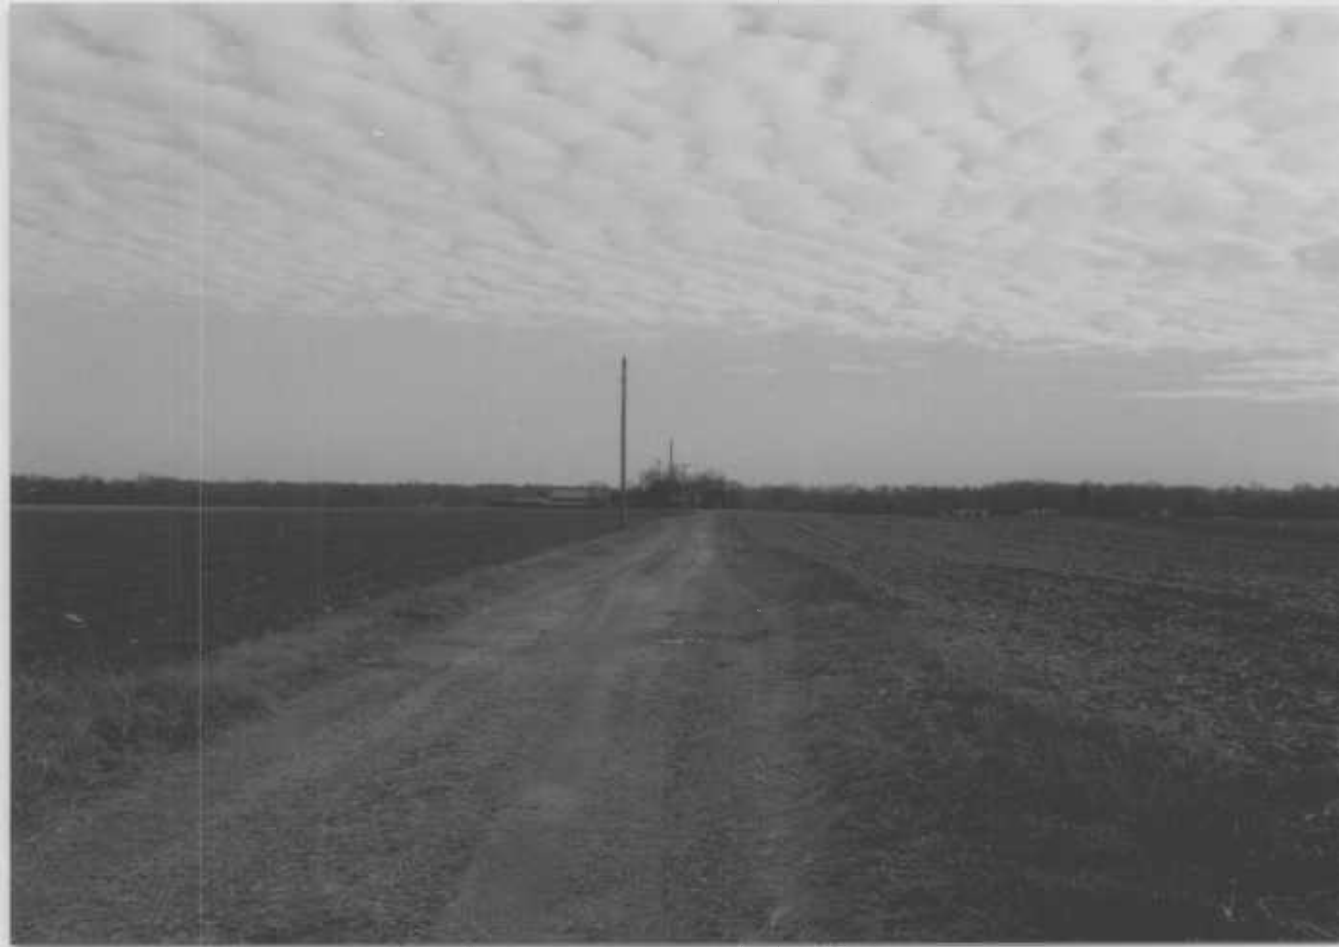
1/7

The property is a farmstead located south of Matthewstown Road and east of Mullet Branch Road. This farmstead consists of a house and a complex of agricultural outbuildings on 230.8 acres.

Farmstead, view to
South from main
(Matthewstown) Road

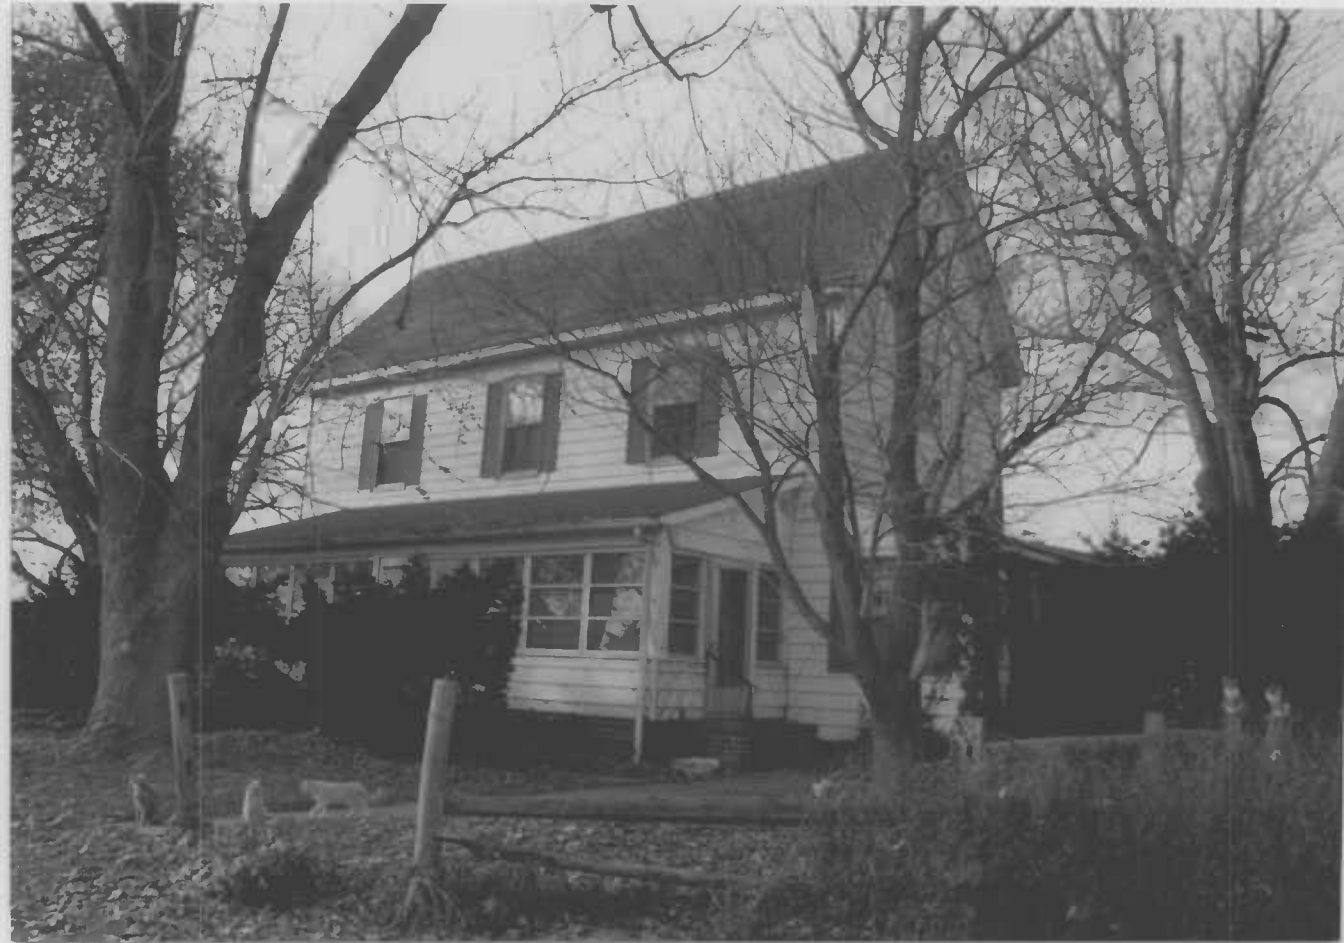
217

The house is a 2½-story frame vernacular L-plan building constructed on a continuous brick foundation. Measuring three bays by one, the house has asymmetrical fenestration. The western elevation, formerly the principal façade, has an enclosed hip-roof porch and a second-story bay window. There are two shed roof additions to the east elevations (rear). The southern elevation has an added enclosed shed roof porch that currently is used as the main entrance.

House, South elevation

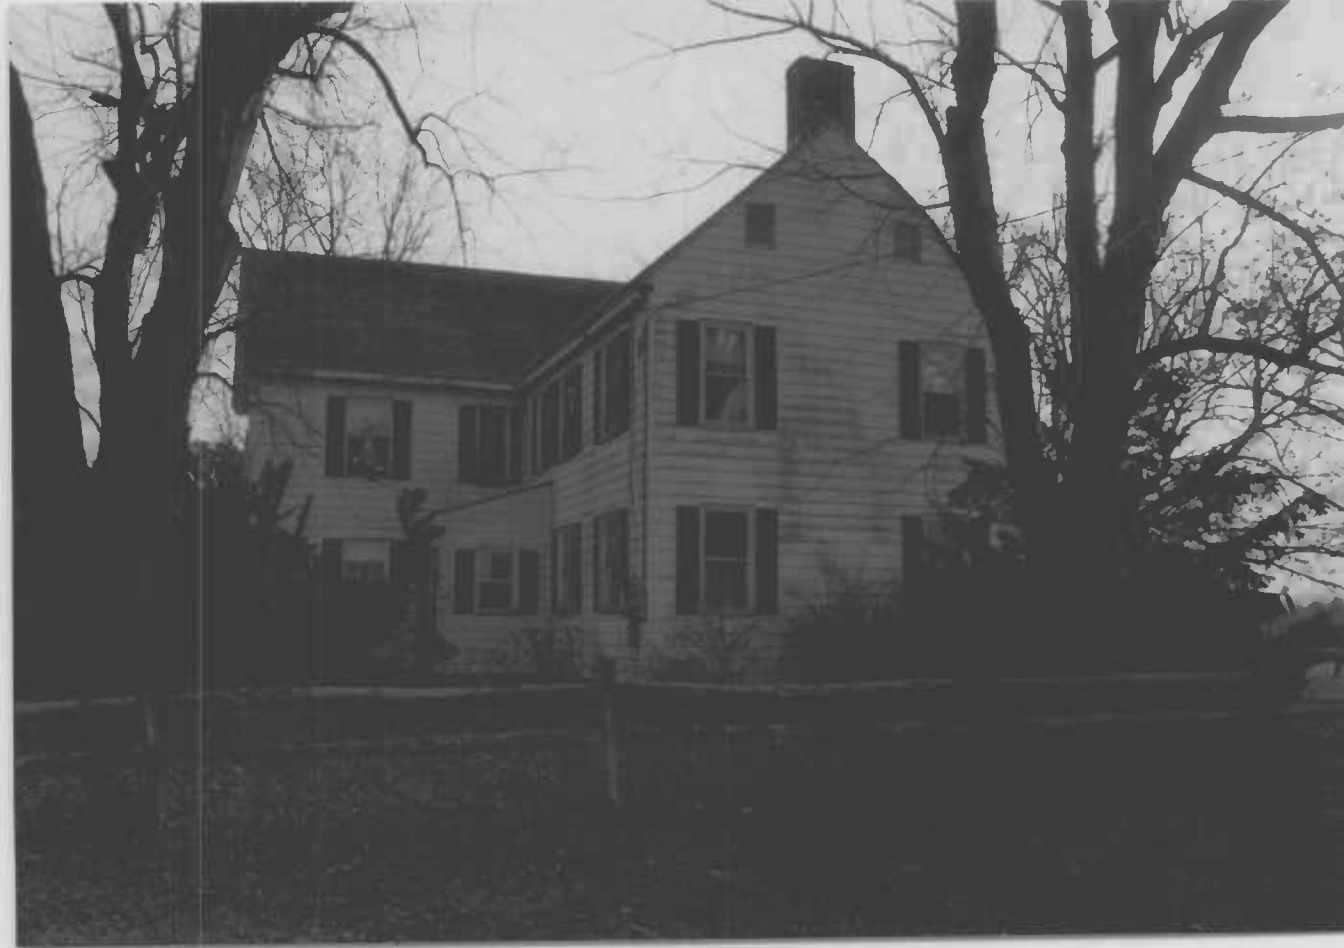
3/7

There is one internal brick chimney. The house has metal double hung sash (6/6 lights) windows and louvered attic ventilators. The windows are highlighted by ornamental shutters. The house is clad by metal siding and the roof is clad by composition shingles.

House, N. elevation

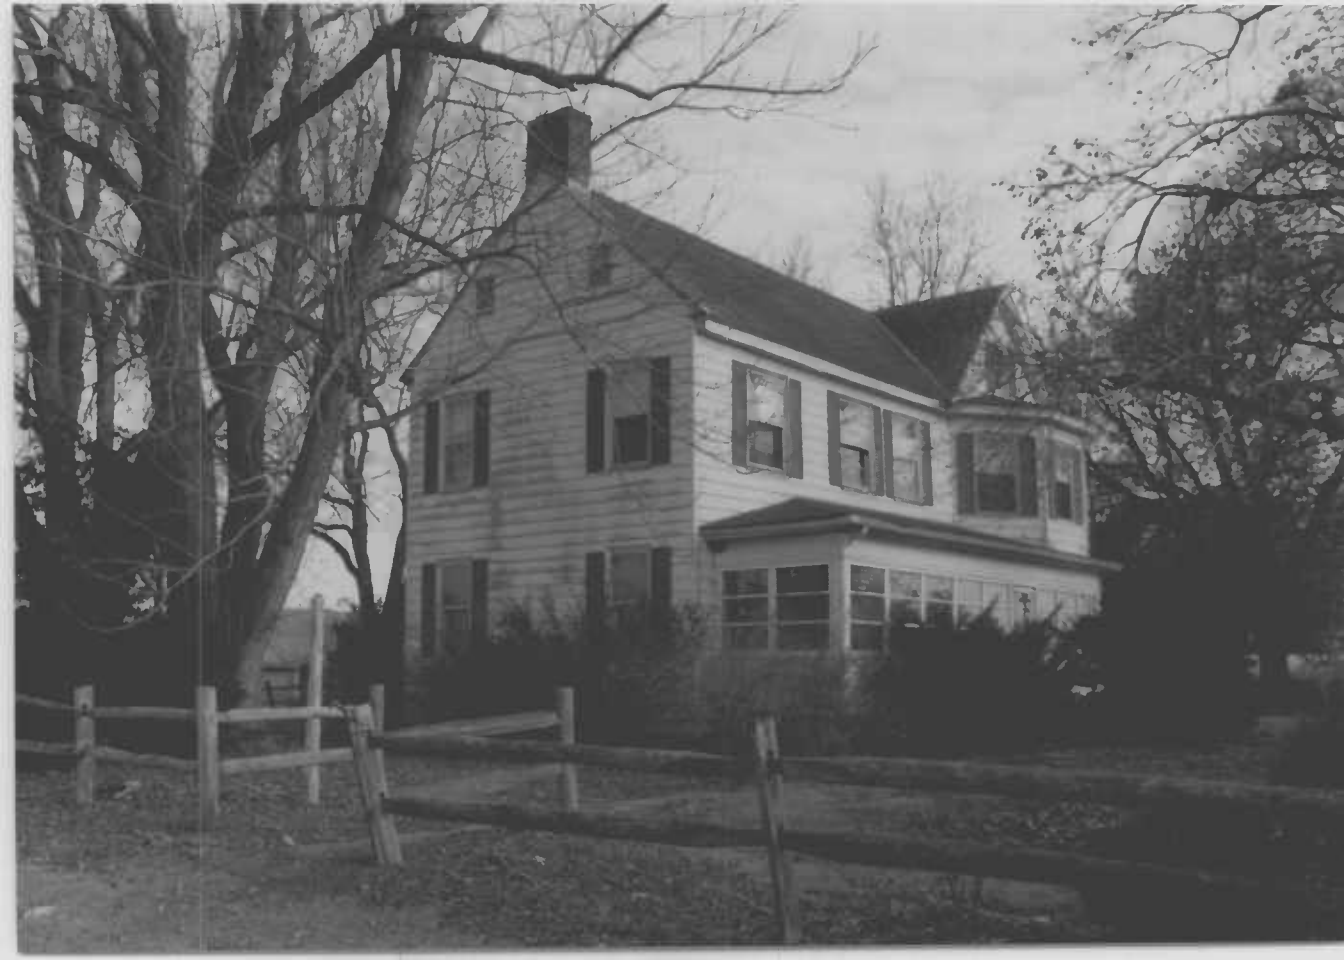
4/7

Howe, North and

West elevations

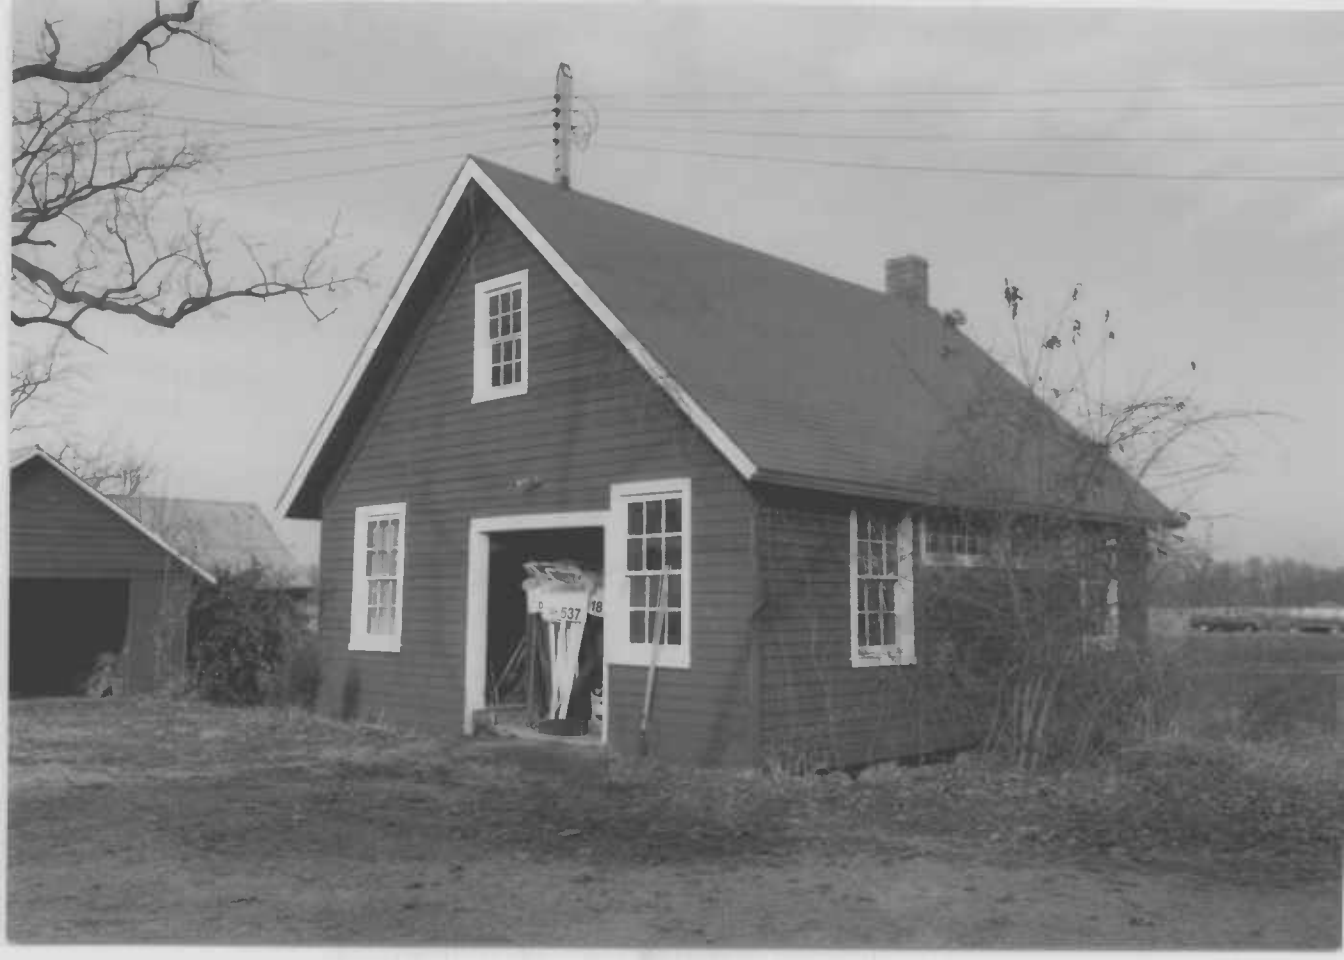
5/7

To the east of the house, there is a wood frame garage constructed on a concrete pad foundation and clad by wood siding and a corrugated metal roof. Also to the east of the house, there is a rectangular one-story wood frame gable-front building. The building has a large gable end entry and wood double hung sash (6/6 lights) windows and fixed-pane windows beneath the eaves. There is a single interior gable-end brick chimney. This building appears to have been built as a blacksmith shop

Blacksmith Shop,

View to South

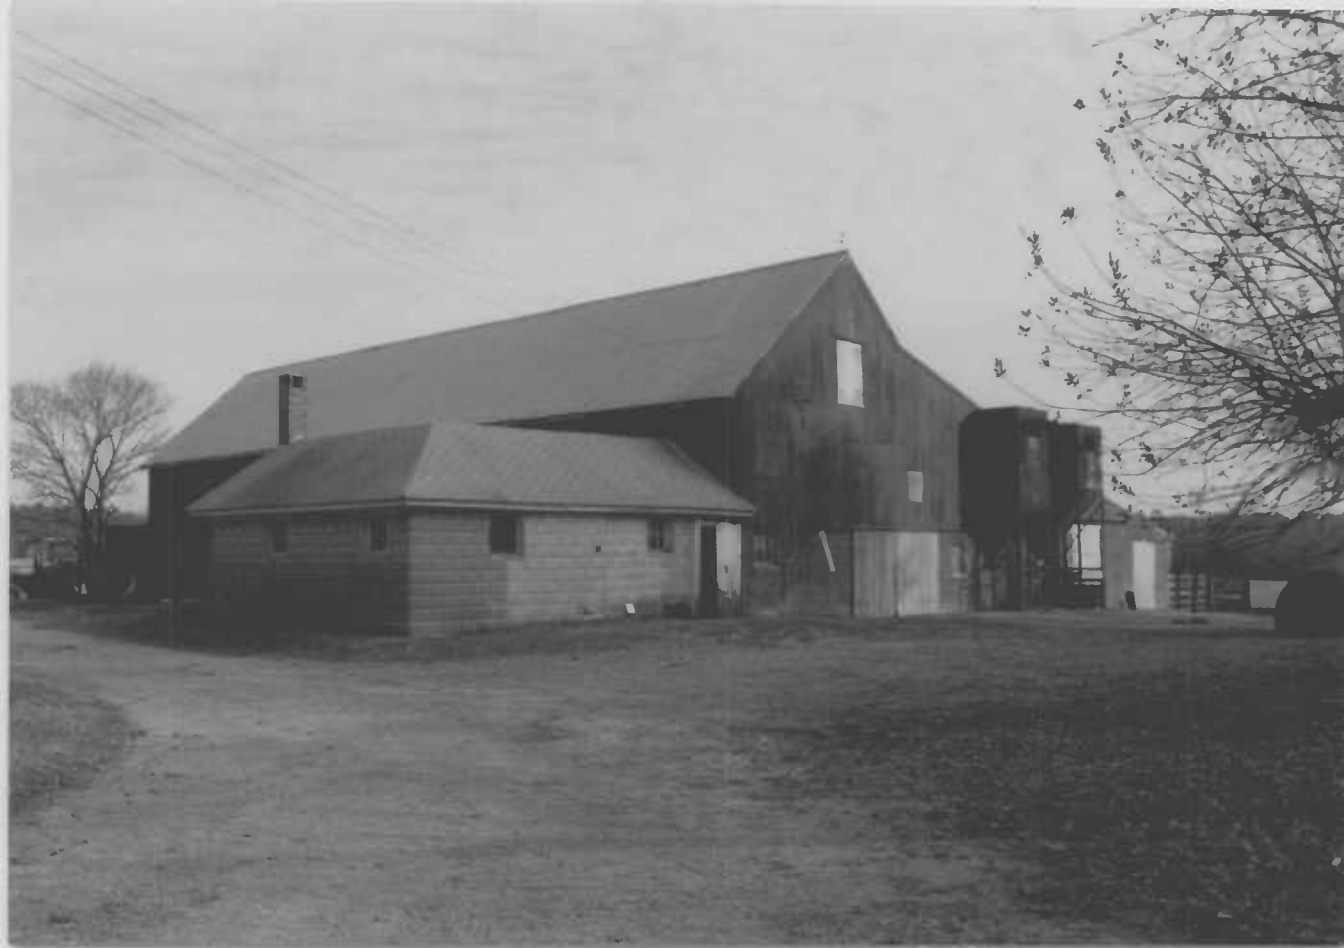
6/7

There is a hip-roof concrete block building of uncertain function located across the unsurfaced drive opposite the rear of the house. The barn is a gable entry building constructed on a concrete block basement. There is a concrete block hip roof addition to the north side of the barn and shed roof additions to the southern side of the barn. The barn is clad by vertical plank siding and its roof is clad by corrugated metal. There are two grain hoppers located flush against the barn's west elevation.

Barn, view to South

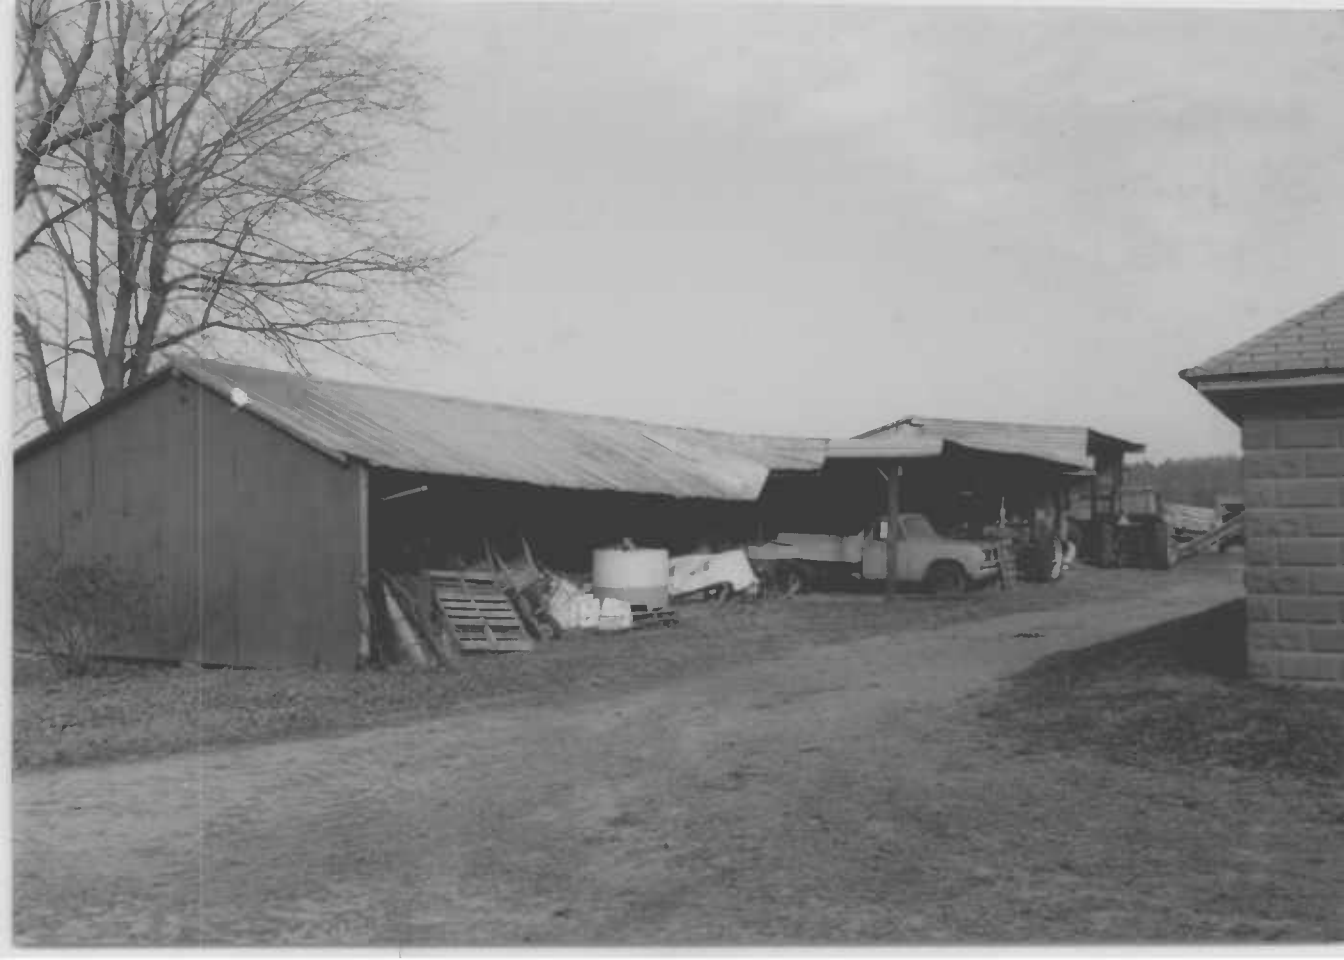
7/7

To the north of the barn, there is an open garage/equipment shed constructed of metal siding with a standing seam metal roof. The agricultural building complex is interconnected via unsurfaced drives.

Sheds, view to
Southeast
